Failure Analysis of OH-58 Kiowa Warrior Drive Gear Shafts

ARL-TR-3827

June 2006

The objective of this report is root cause determination for the 15-hp spare drive gear failure.

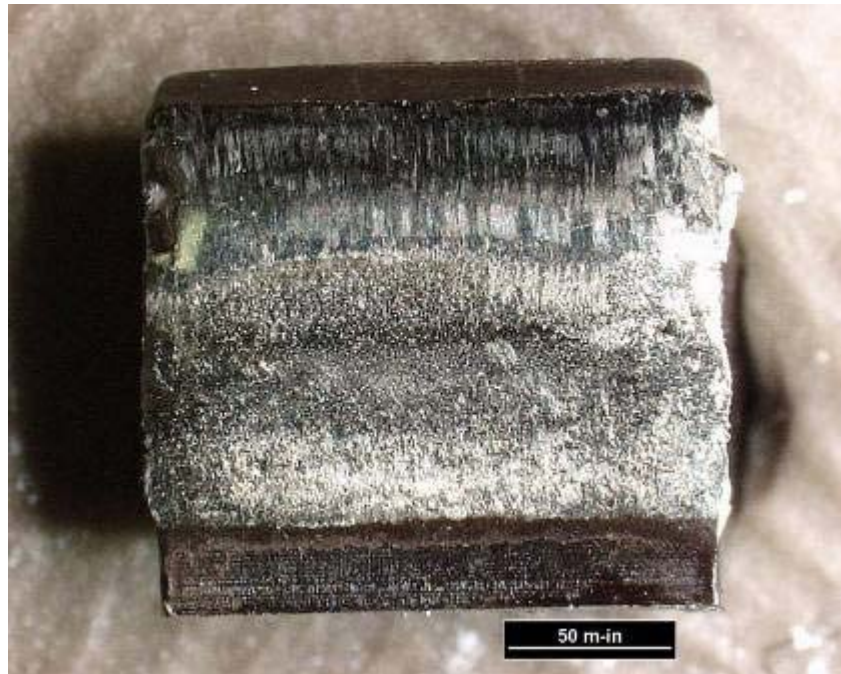
Figure 23. Drive side, tooth 18.

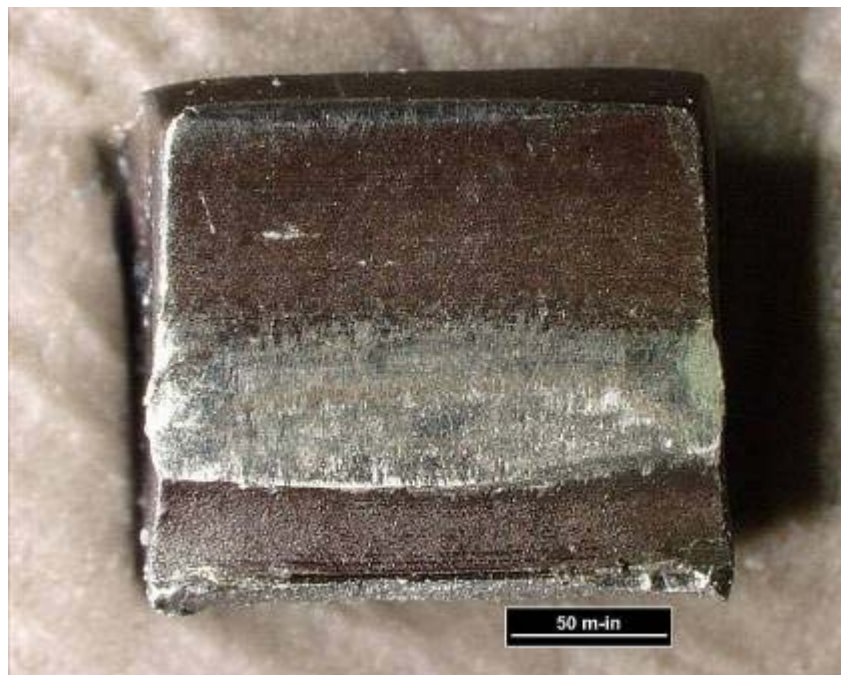
Figure 24. Coast side, tooth 18.

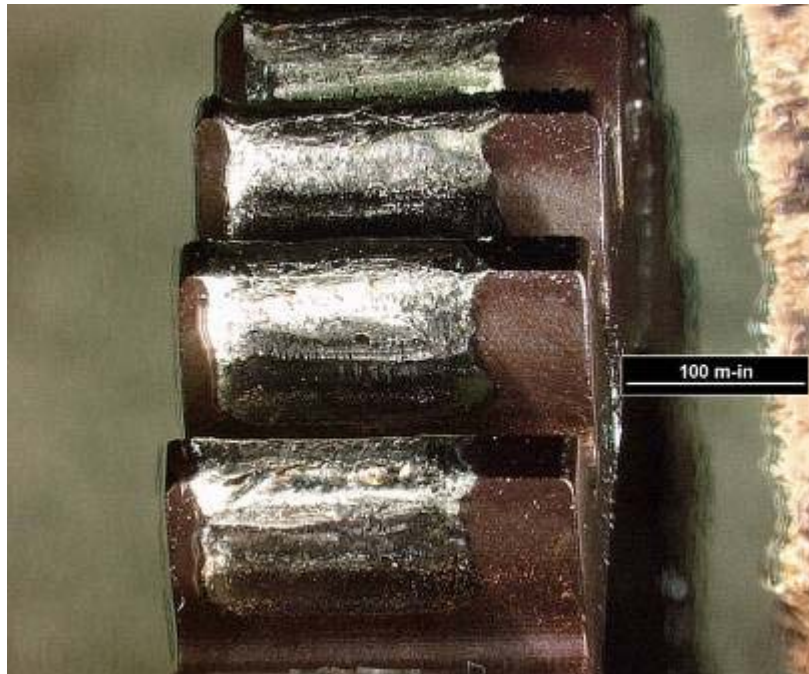
Figures 33 and 34 show the drive and coast sides of the mating pinion. Note that the wear pattern is offset, as the spare drive gear is not centered with respect to the pinion.

Figure 33. Drive side idler gear.

Figure 34. Coast side idler gear.
